**REPORT OF SUPPLEMENTAL
REMEDIAL INVESTIGATION
L. E. CARPENTER FACILITY
WHARTON, NEW JERSEY
VOLUME I**

November 1990

**Weston Services, Inc.
West Chester, Pennsylvania**

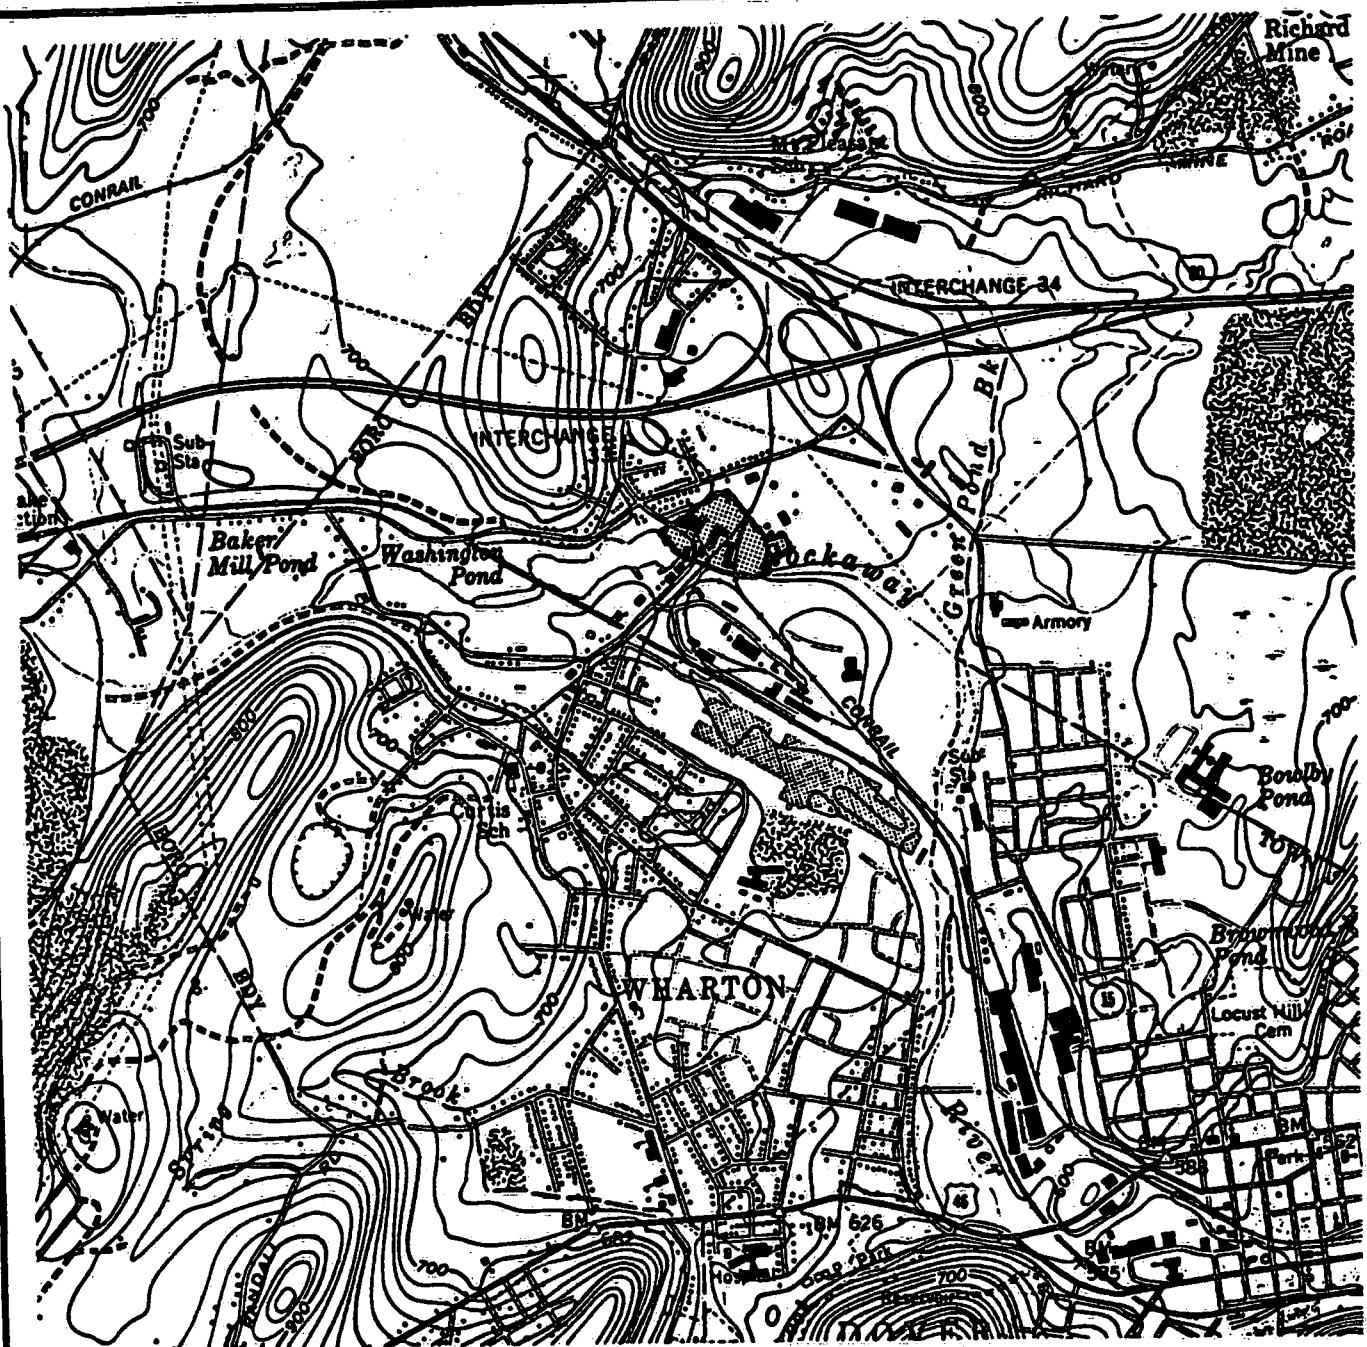
FIGURE 1-1 SITE LOCATION AND TOPOGRAPHIC MAP

A detailed description of the site is provided in the "Revised Report of Remedial Investigation Findings" (GeoEngineering and WESTON, June 1990). The L.E. Carpenter site occupies approximately 14.6 acres in an industrial area of Wharton, New Jersey, as shown in Figure 1-1. The site is bounded on the south by the Rockaway River, on the east by a vacant lot owned by Wharton Enterprises, on the northeast by a compressed gas facility (Air Products, Inc.), on the northwest by Ross Street and a residential area, and on the west by Washington Forge Pond as shown in Figure 1-2. A drainage ditch drains a portion of the site, the Air Products property, and eventually discharges to the Rockaway River downstream of the site. The site is bordered by a security fence along North Main and Ross Streets, which separates it from the Air Products property.

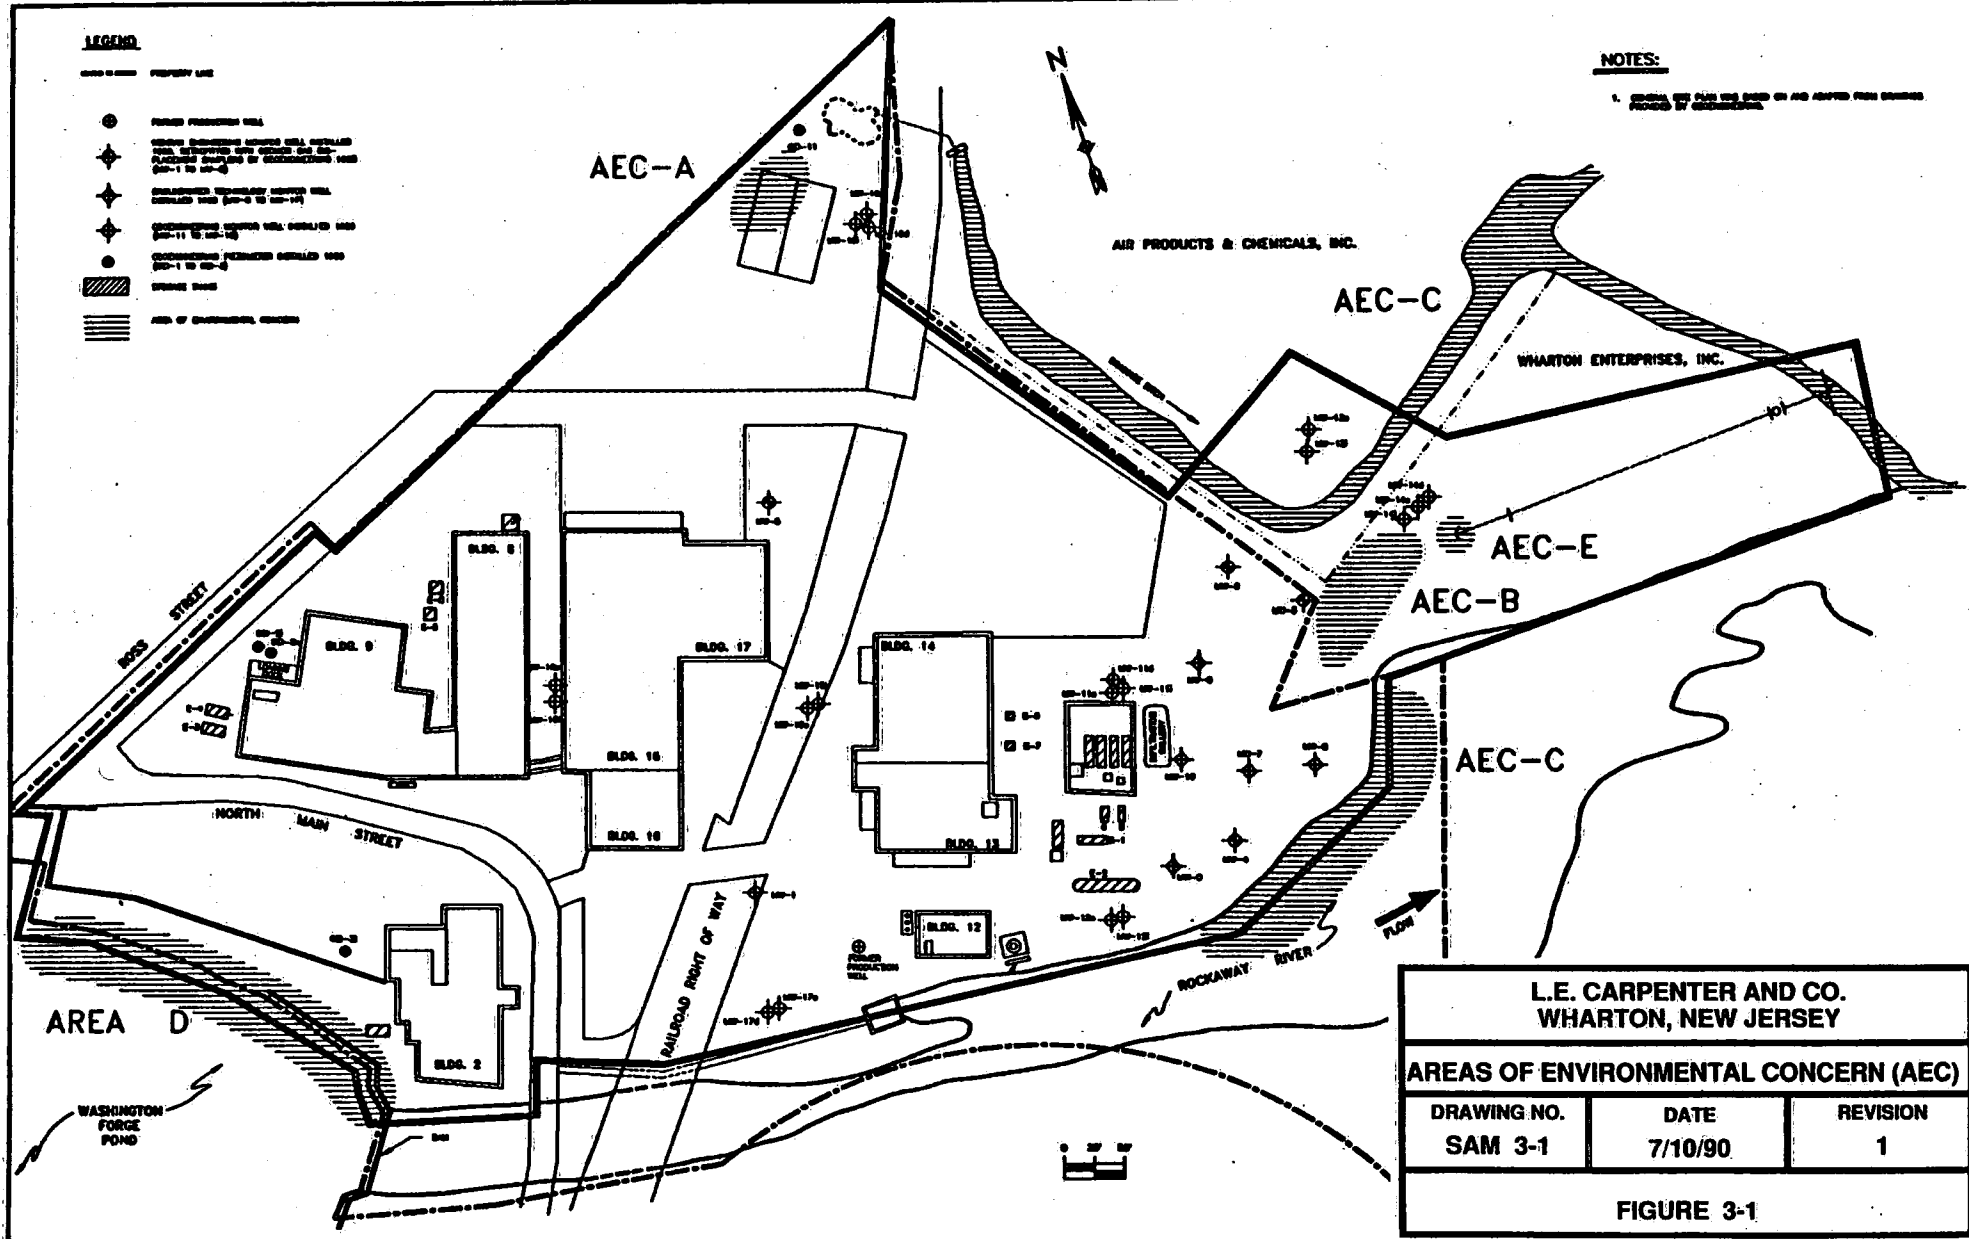
FIGURE 3-1

AREAS OF ENVIRONMENTAL CONCERN (AEC)

line. The area is called AEC-B and is shown in Figure 3-1. The former sludge impoundment area is shown in Plate 1 in the vicinity of monitoring well MW-4.

AEC-C is composed of the drainage ditch that follows the approximate property boundary between Air Products & Chemical, Inc. and the L.E. Carpenter site as shown in Figure 3-1. This ditch receives runoff from off-site, and sheet runoff from a limited area of the L.E. Carpenter site immediately adjacent to the ditch. In addition, drainage from several paved areas of the site discharge to a storm sewer that discharges to this drainage ditch. The

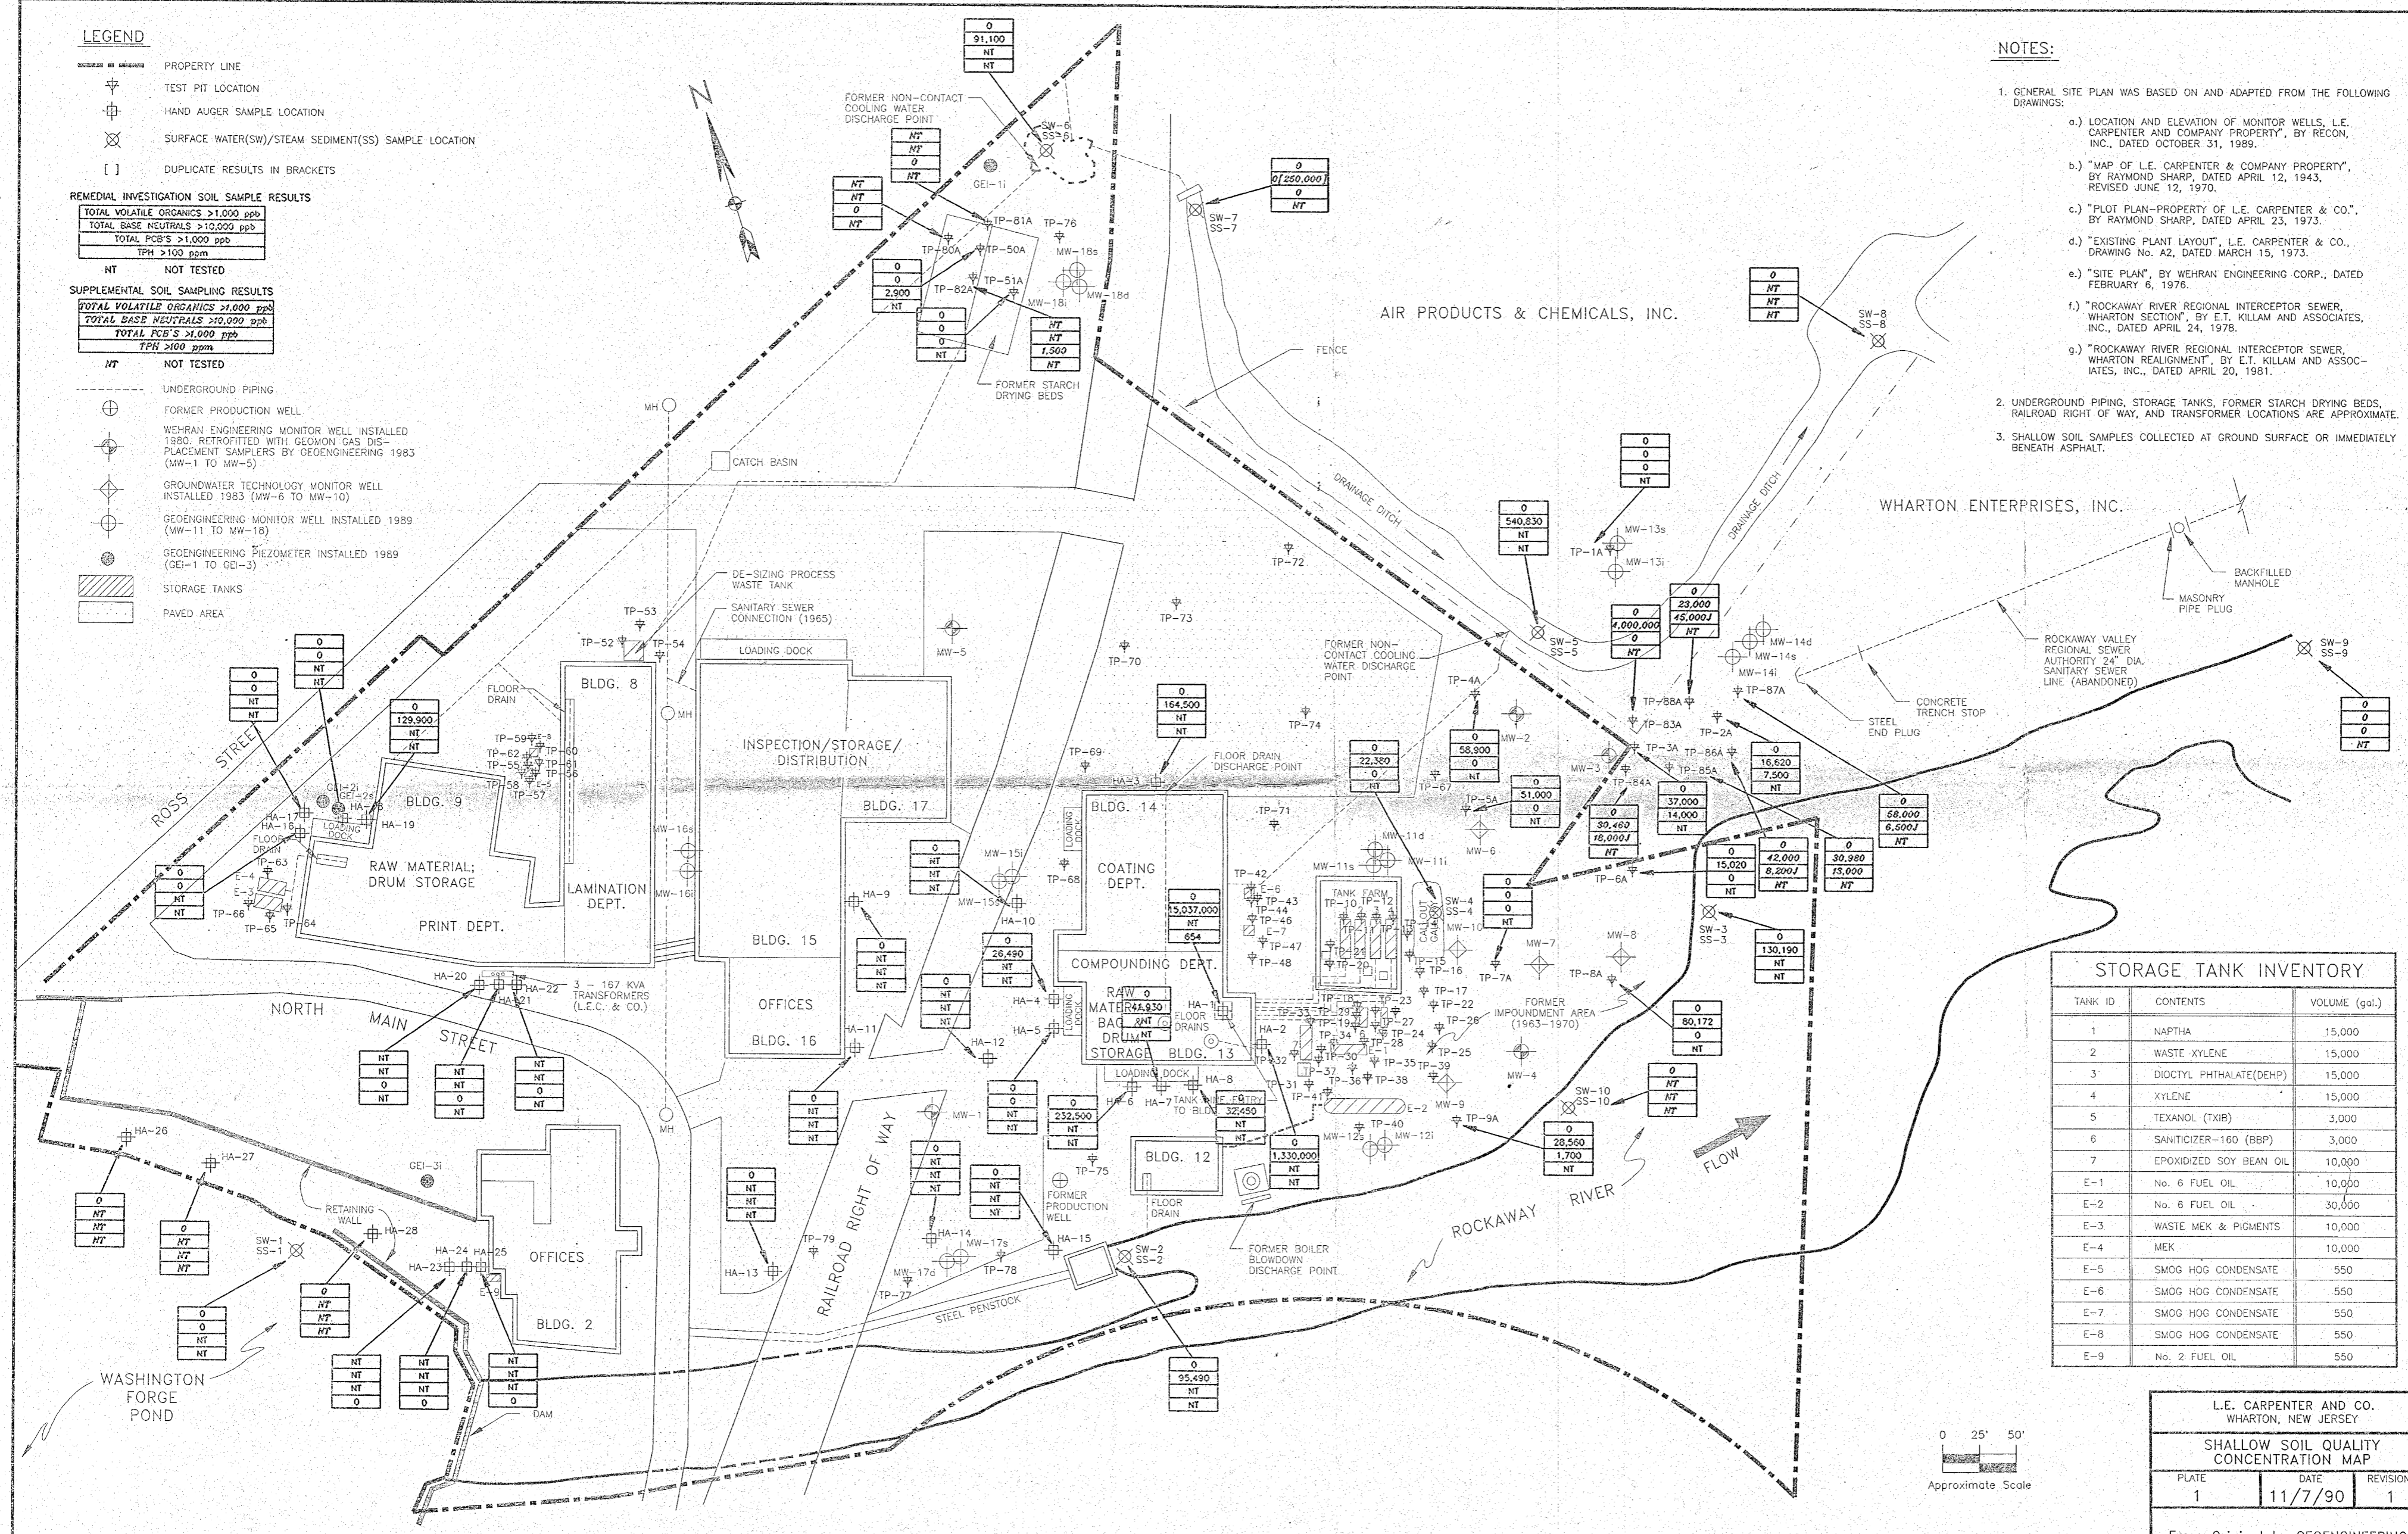
- UNDERGROUND PIPING, STORAGE TANKS, FORMER STARCH DRYING BEDS, RAILROAD RIGHT OF WAY, AND TRANSFORMER LOCATIONS ARE APPROXIMATE.
- SHALLOW SOIL SAMPLES COLLECTED AT GROUND SURFACE OR IMMEDIATELY BENEATH ASPHALT.

Test pits TP-80, TP-81, and TP-82 are located within 20 feet of either test pit TP-50 or TP-51 where PCB was detected during the RI. These locations are shown on Plate 1. Fill consisting of silty sand with gravel and cobbles and broken concrete fragments, some with steel rebar, was encountered from 0 to 2 feet in test pits TP-80 and TP-81. The soil encountered below the fill in test pits TP-80 and TP-81 and in the test pit TP-82 consisted of silty sand, silty sand with gravel, and sandy silt and cobbles. Groundwater was encountered between 3.5 and 4 feet below ground surface in each of the three test pits. No odors were observed in the test pits. Appendix A includes test pit logs.

The results of the PCB analysis for samples from the three test pits TP-80, TP-81 and TP-82 are shown in Plate 1 (shallow soil) and Plate 3 (deep soil) and listed in Table 3-2 along with the previous results from RI test pits TP-50, TP-51, and TP-76. As with the previous results from test pits TP-50 and TP-51, the PCB detected in samples from test pits TP-80, TP-81, and TP-82 was Arochlor-1254. These results indicate that the extent of PCB in excess of 1,000 $\mu\text{g}/\text{kg}$ in soil is from ground surface to a depth of between 2 and 3 feet within the area enclosed by test pits TP-51, TP-81, TP-80, and TP-82.
